## **Composite Failure Analysis Handbook Update #1**

*Greg Walker*

*Boeing Defense & Space Group*

**April 1995**

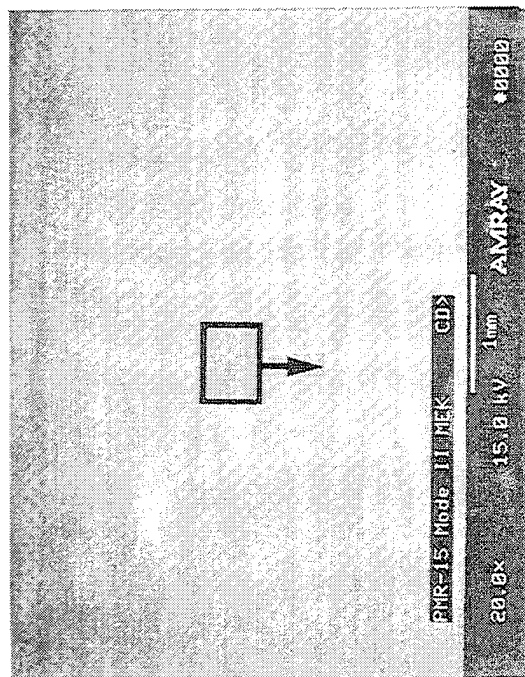
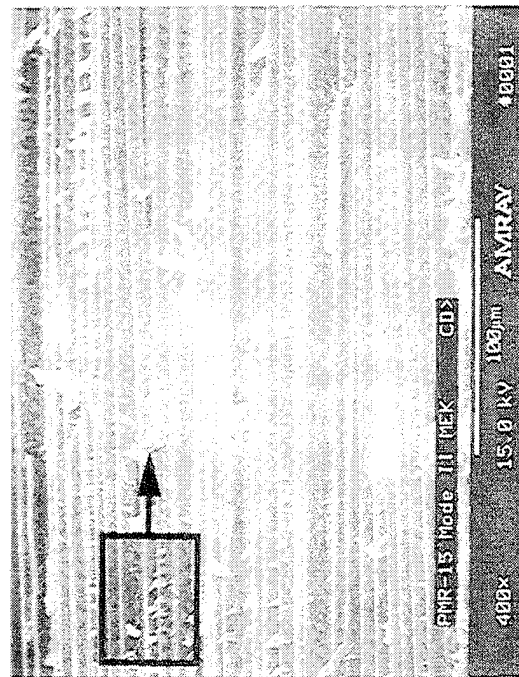
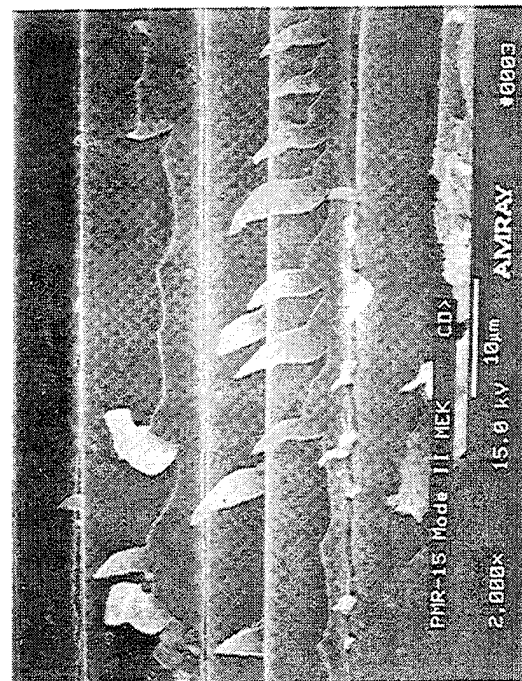
Figure 3.3-18. SEM Fractographs of a PMR-15/AS4 Interlaminar Mode II Shear Fracture Surface Exposed to MEK for 24 Hours

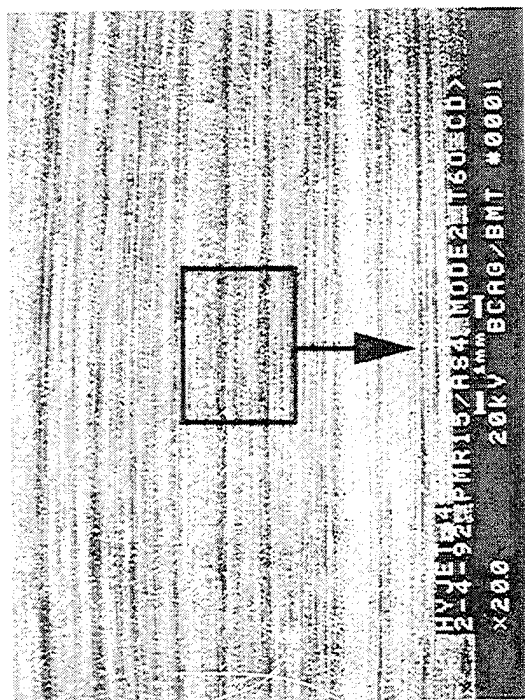
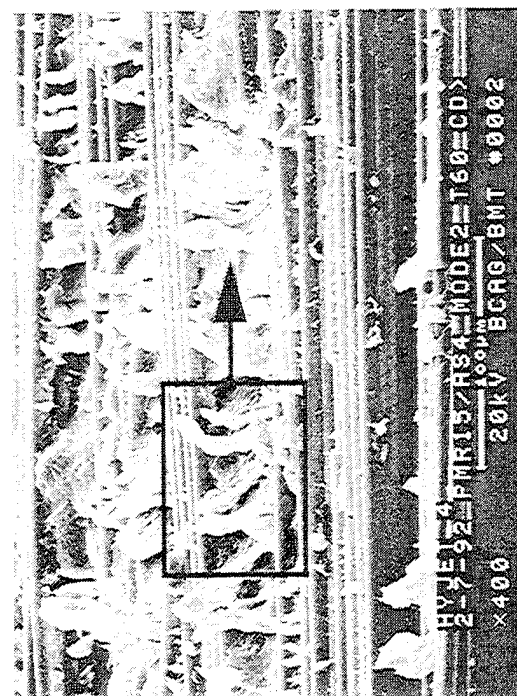
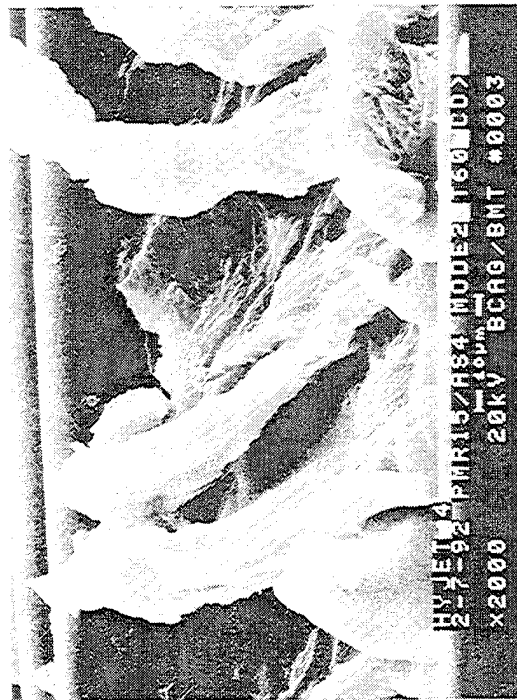
Figure 3.3-19. SEM Fractographs of a PMR-15/AS4 Interlaminar Mode II Shear Fracture Surface Exposed to Hydraulic Fluid for 7 Days

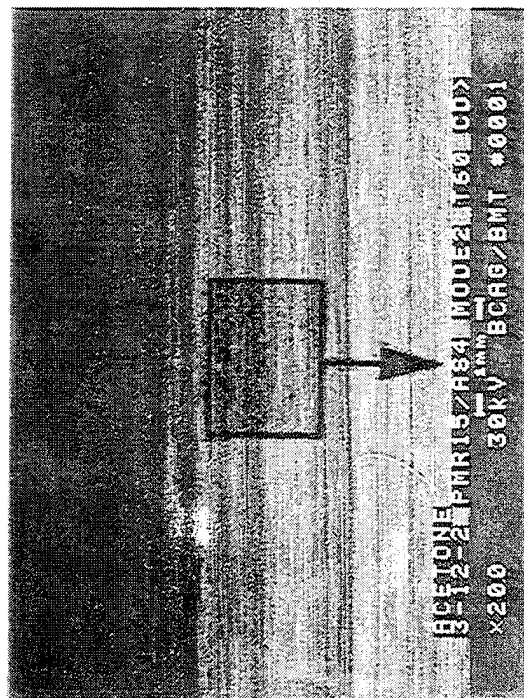
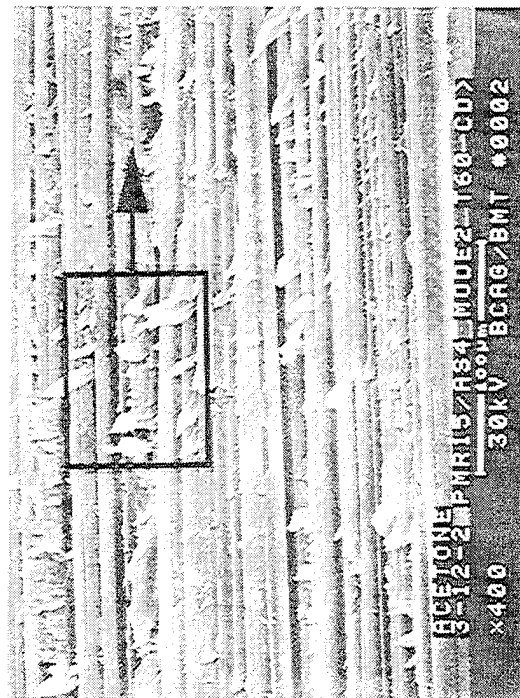
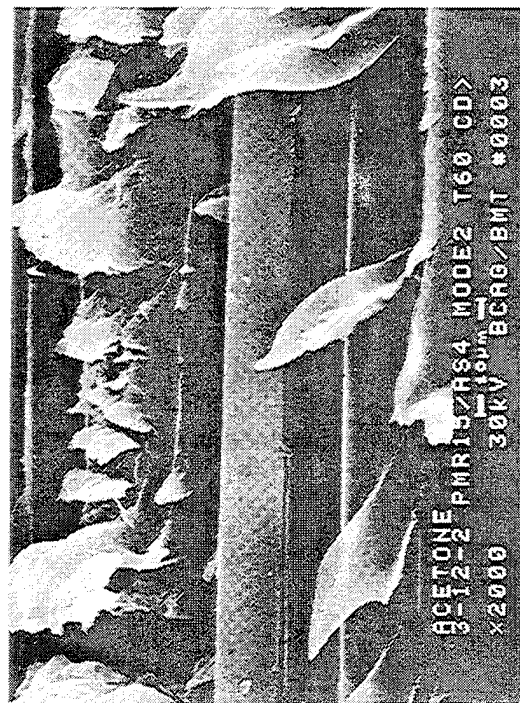
Figure 3.3-20. SEM Fractographs of a PMR-15/AS4 Interlaminar Mode II Shear Fracture Surface Exposed to Acetone for 24 hours

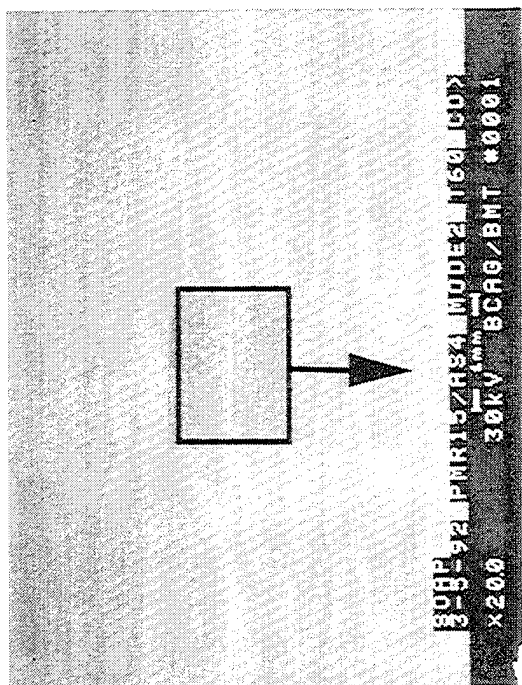
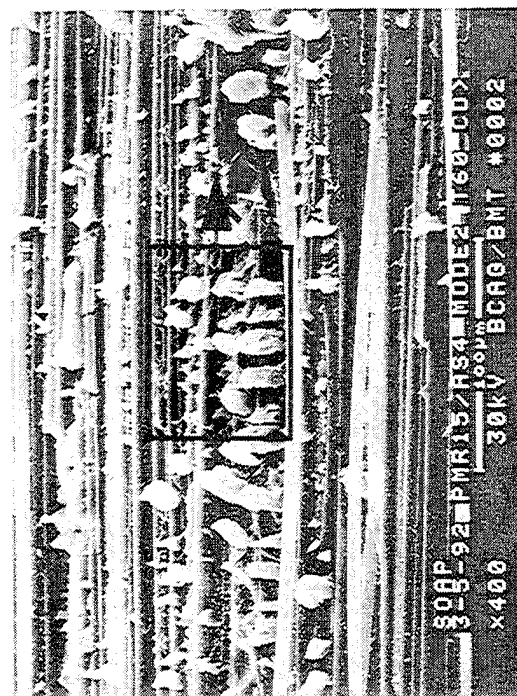
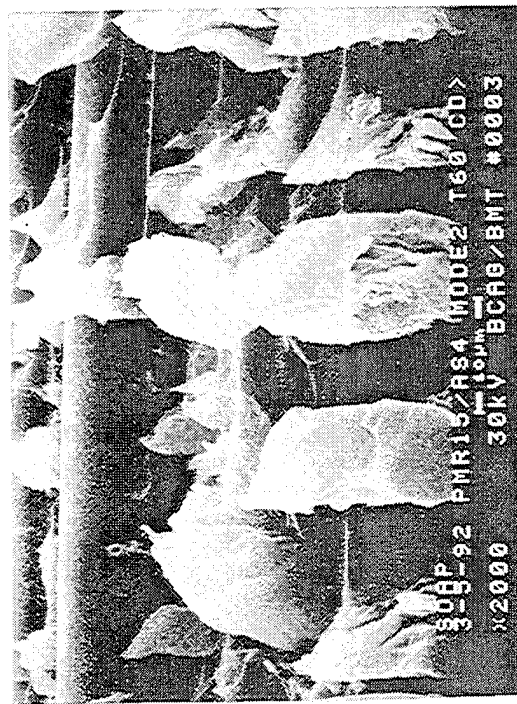
Figure 3.3-21. SEM Fractographs of a PMR-15/AS4 Interlaminar Mode II Shear Fracture Surface Exposed to Soap Solution for 24 hours

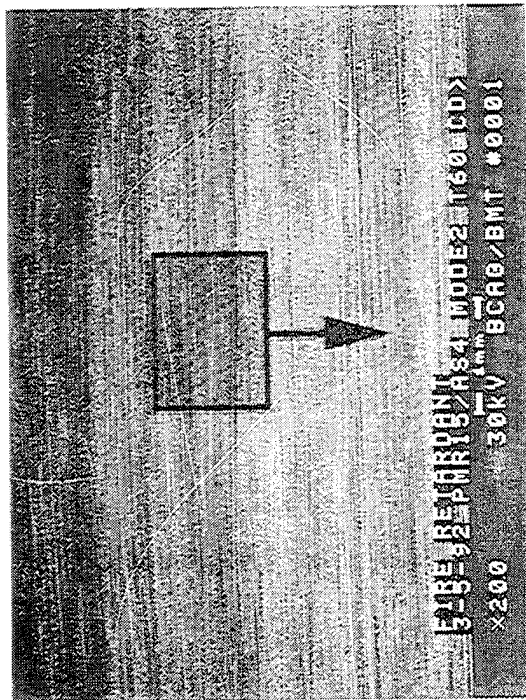
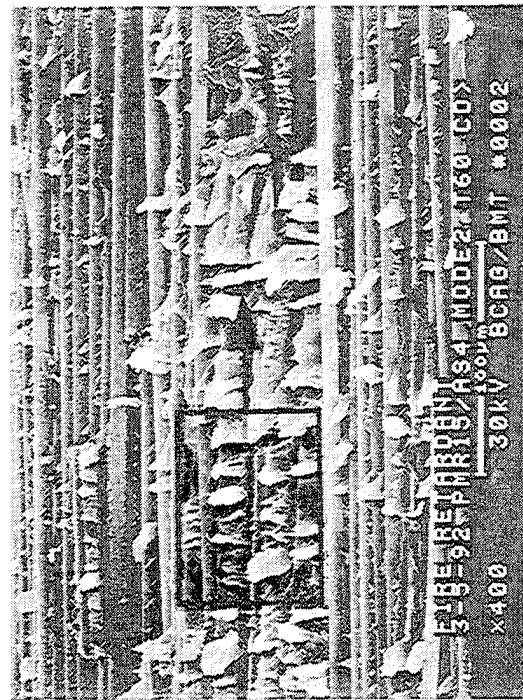
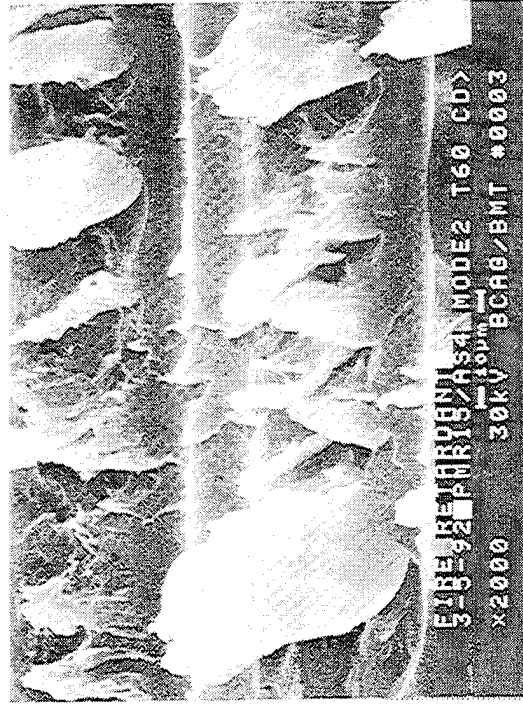
Figure 3.3-22. SEM Fractographs of a PMR-15/AS4 Interlaminar Mode II Shear Fracture Surface Exposed to Fire Retardant Foam for 7 Days

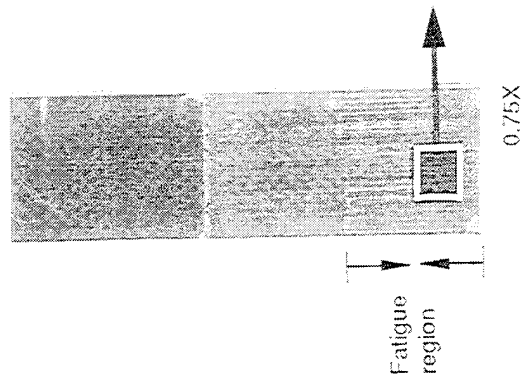
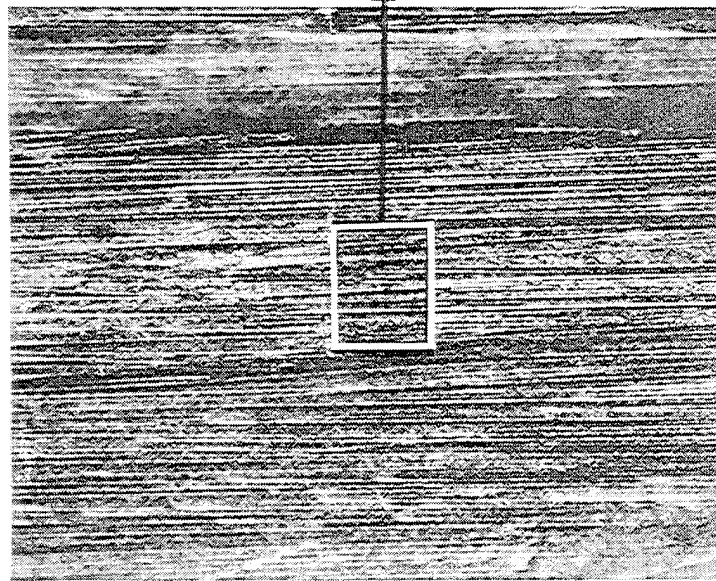
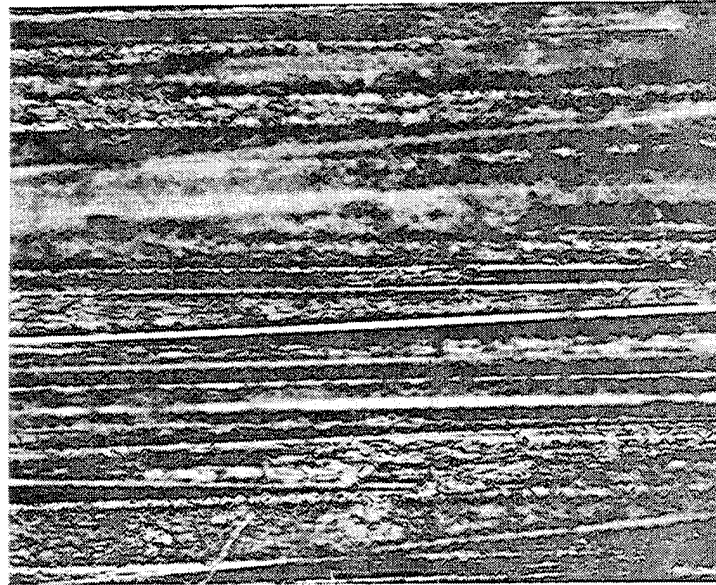
As shown in Figures 3.4-1 and 3.4-2, the fracture surface morphology of the RT specimen appeared typical for the mode II (shear) Gr/PEEK fracture surface. However, the hackle feature on this surface was considerable smaller than the statically loaded specimen and was probably unique to the cyclic loading.

Figure 3.4-1. Optical Fractographs of PEEK/AS4 Interlaminar Mode II (Shear) Fatigue, Room Temperature, High Stress

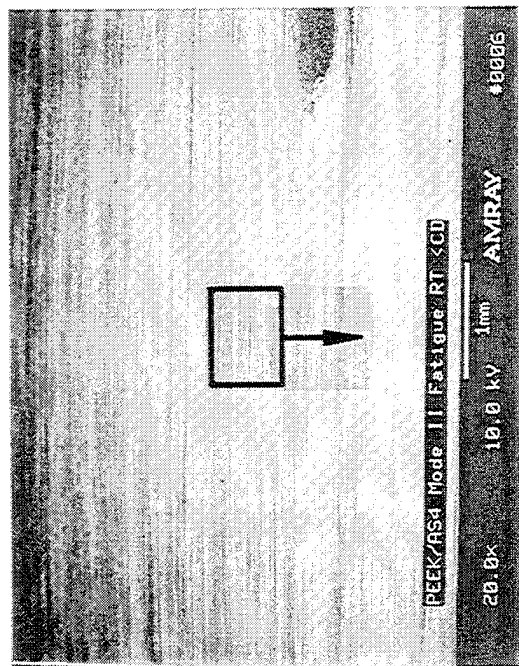
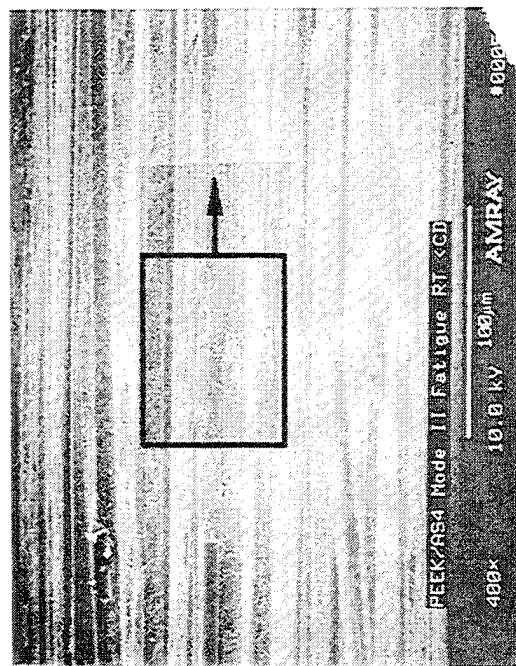
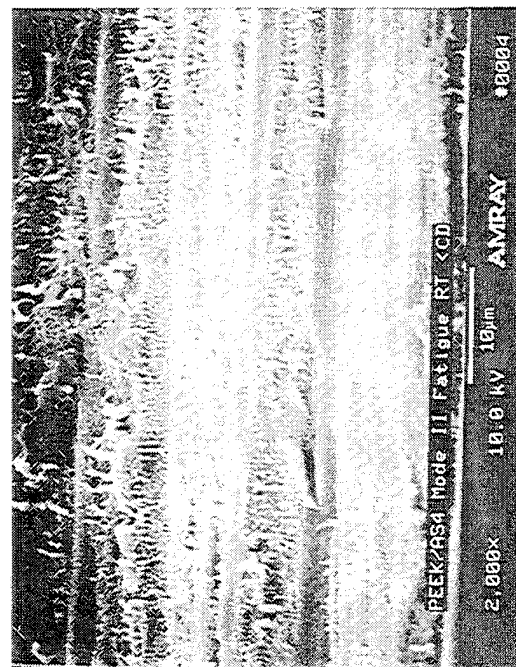
Figure 3.4-2. SEM Fractographs of a PEEK/AS4 Interlaminar Mode II (Shear) Fatigue Fracture Surface, Room Temperature

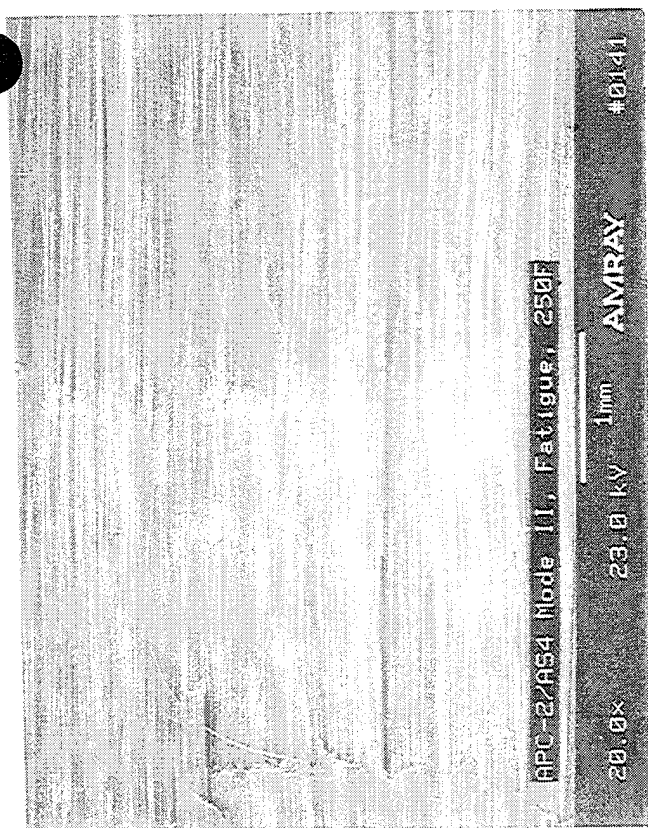
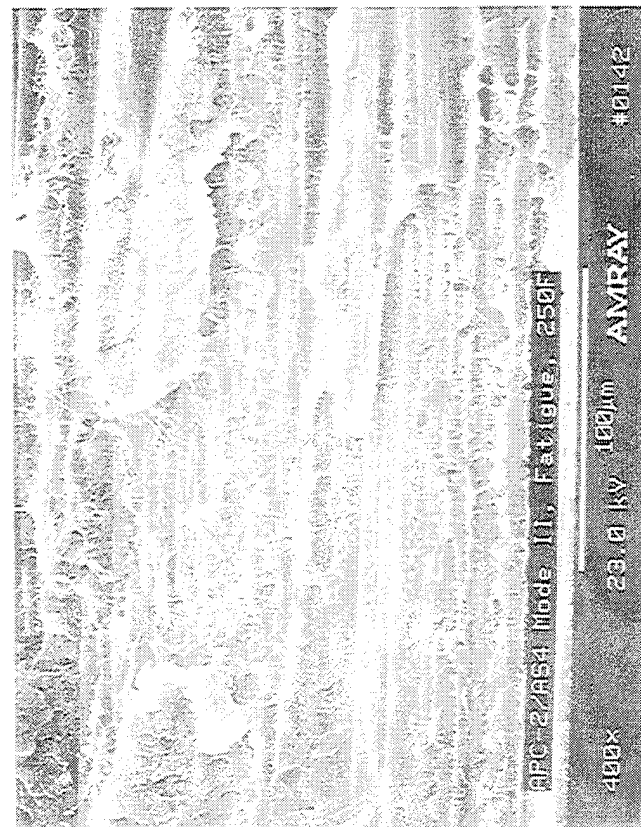
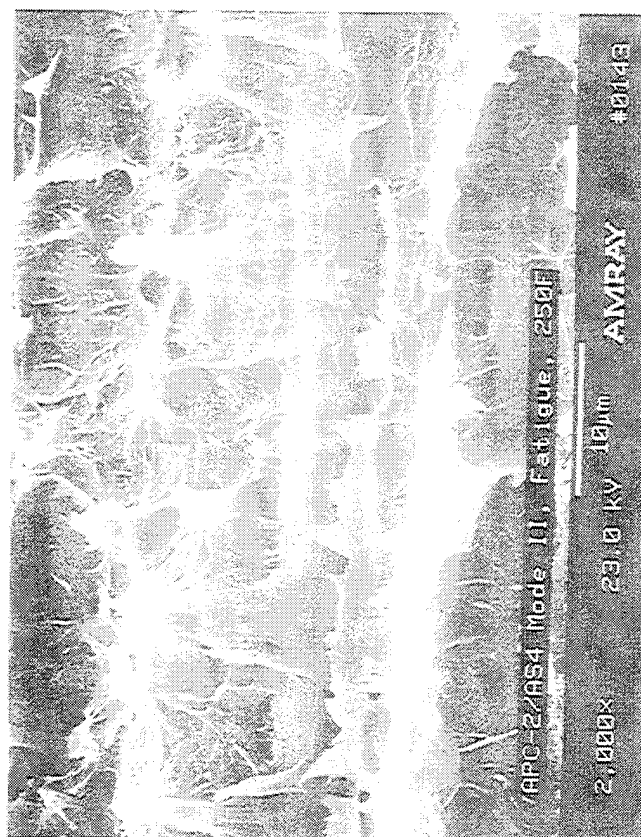
The fracture morphology was very different on the specimen tested at 250°F (Figures 3.4-3 and 3.4-4). The resin was pulled out in "ribbons" which did not indicate the overall crack propagation direction.

Figure 3.4.4. SEM Fractographs of a APC-2/AS4 Interlaminar Mode II (Shear) Fatigue Fracture Surface, 250° F

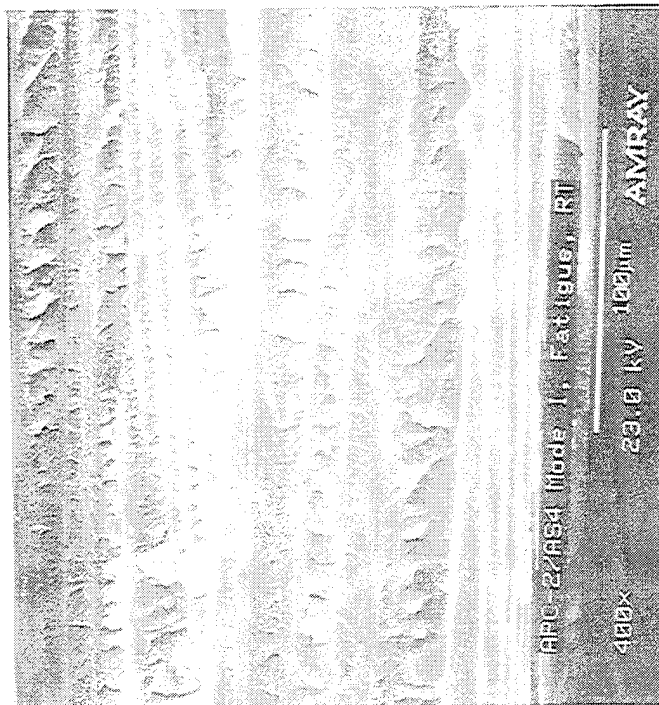
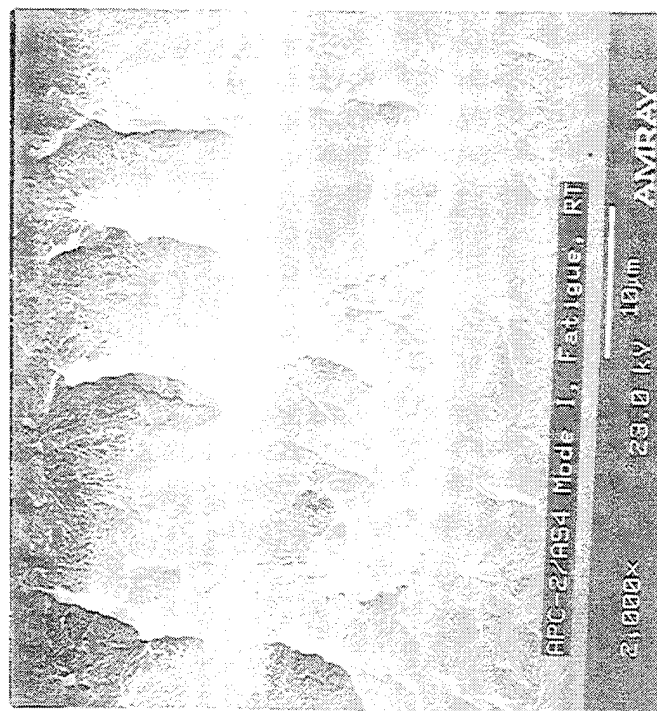
The RT fracture surface (Figures 3.4-5 and 3.4-6) exhibited features similar to large hackles between the fibers, oriented in the direction of the overall crack propagation direction. The plastic craze was also present throughout the entire surface including the large hackles.

Figure 3.4-6. SEM Fractographs of a APC-2/AS4 Interlaminar Mode I (Tensile) Fatigue Fracture Surface, RT

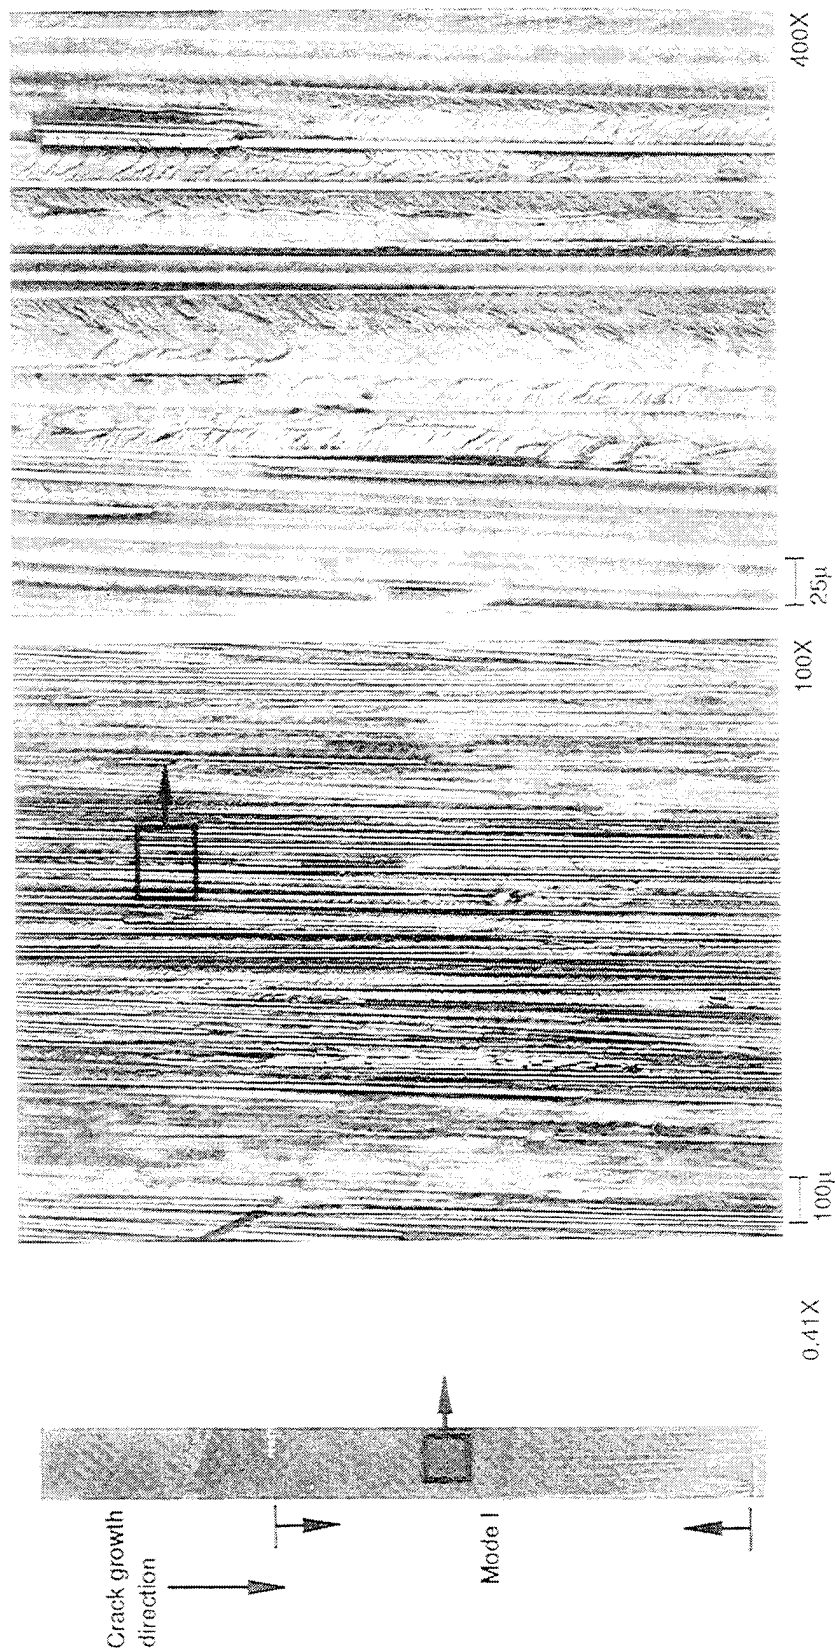
Figure 3.5-1. Optical Fractographs of BMI/AS4 Interlaminar Mode I Tension Specimen Tested at 111/Dry

Visual observation revealed a smooth, glassy surface typical of an interlaminar mode I tension fracture. However, fragments of loose fibers were apparent on the fracture surface. These fibers were separated from the matrix (possibly due to weak fiber/matrix adhesion). Under the optical microscope, fine rivermarks were observed, indicating the overall crack propagation direction (Figure 3.5-1). As shown in Figure 3.5-2, SEM examination revealed rivermarks between the carbon fibers. These rivermarks indicated the crack growth is consistent with the mechanically induced crack direction.

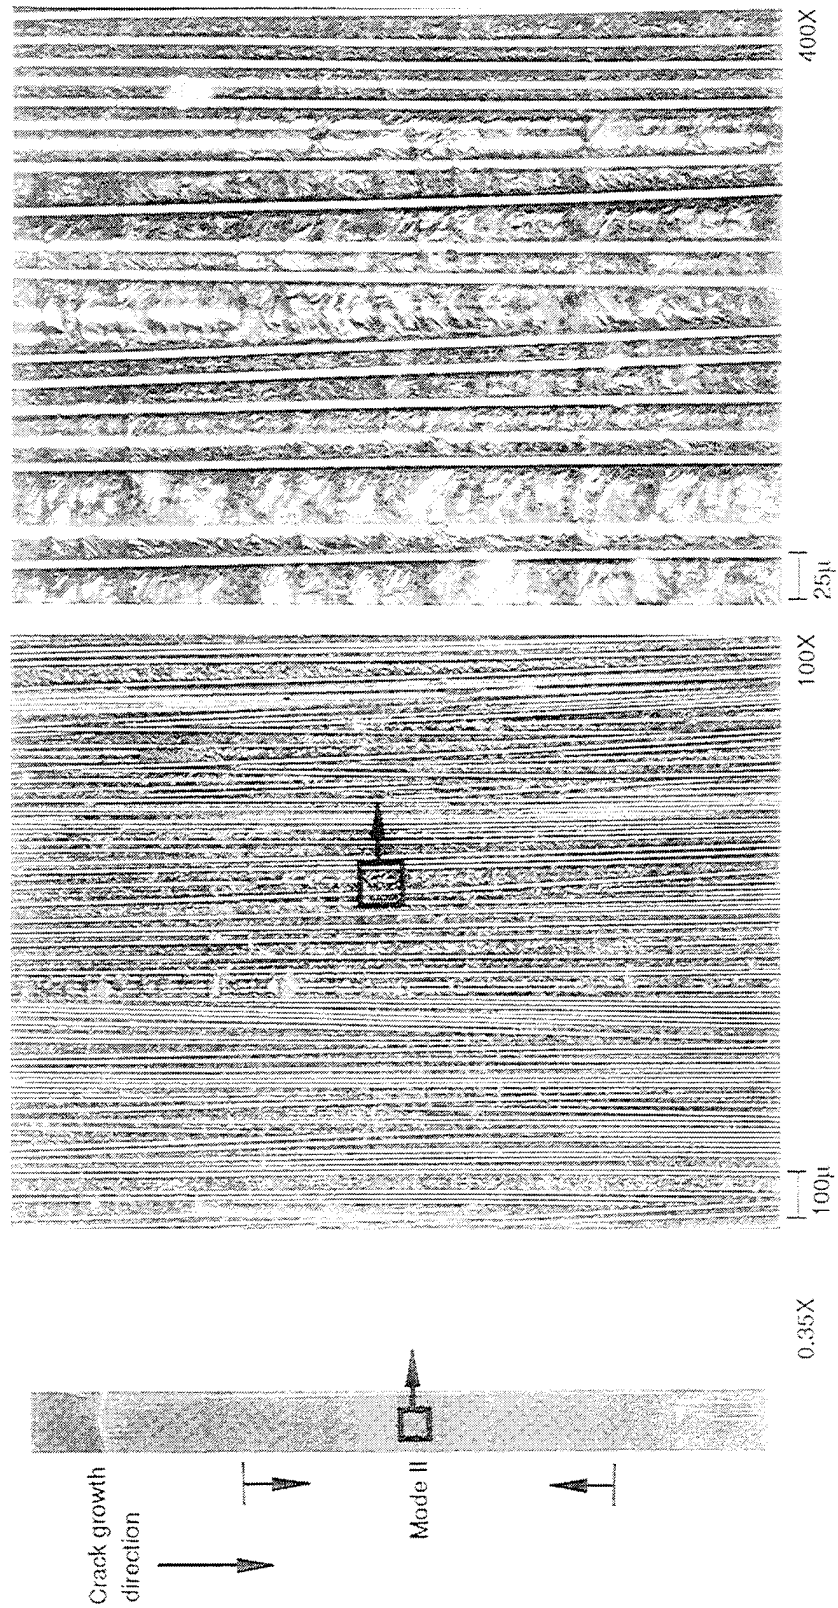
Figure 3.5-3. Optical Fractographs of BMI/AS4 Interlaminar Mode II Shear Specimen Tested at RT/Dry

Visual observation of the fracture surface revealed a flat but milky appearance when held at an angle to the light. The milky appearance is due to the hackle formation created by shear loading, which was observed at higher magnification under the optical microscope (Figure 3.5-3). SEM examination revealed hackles of different sizes, shapes, and tilt angles located between the carbon fibers (Figure 3.5-4).

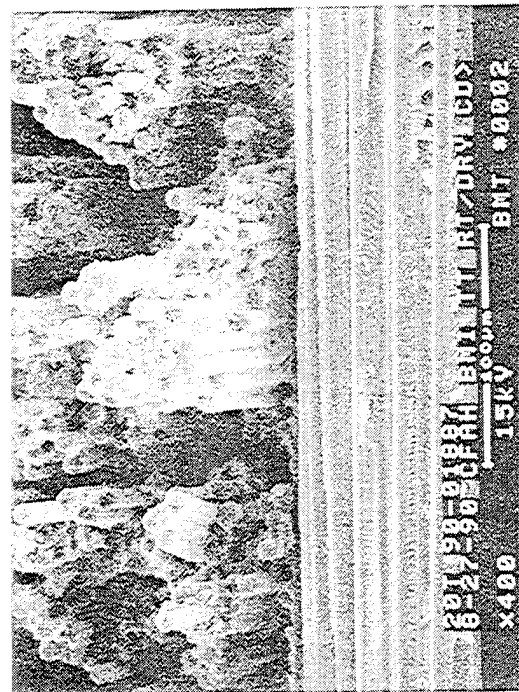
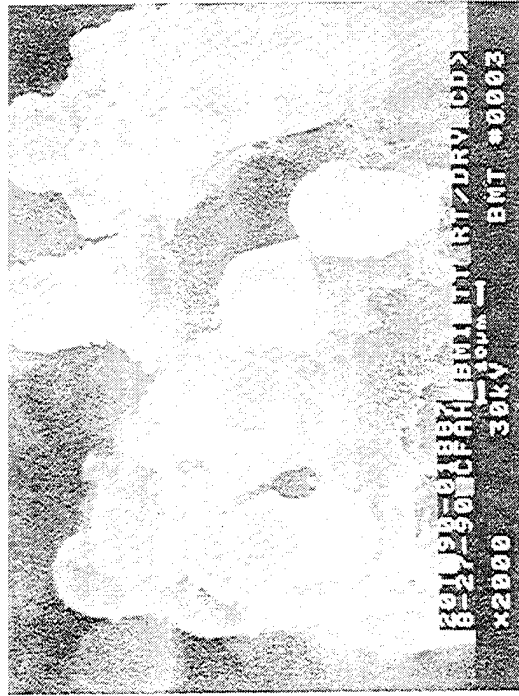
Figure 3.5-5. SEM Fractographs of an AS4/BMI Translaminar Tension RT/Dry Fracture

SEM fractography (Figure 3.5-5) revealed radial patterns on the fiber ends, indicating a resultant crack direction consistent with the mechanically induced direction. The specimen tested at 450° F did not fracture but only bent during the testing (Figure 3.5-6)

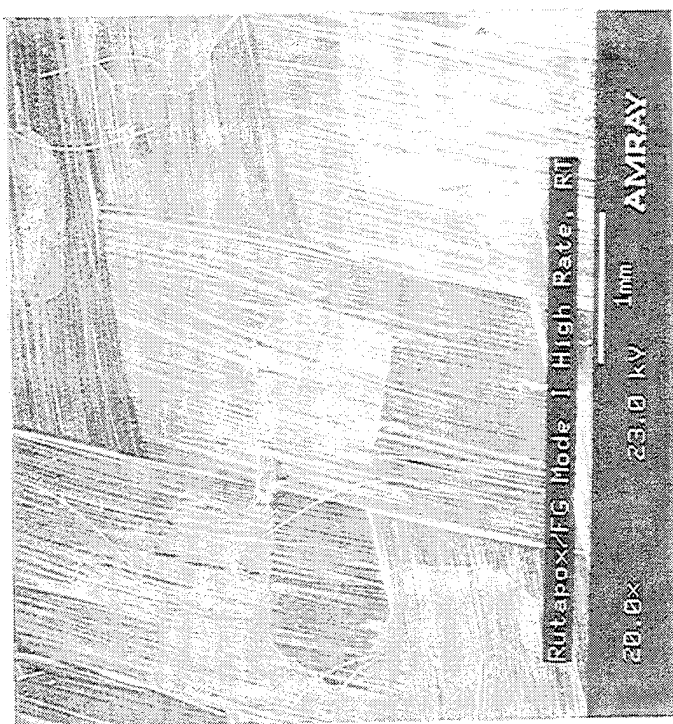
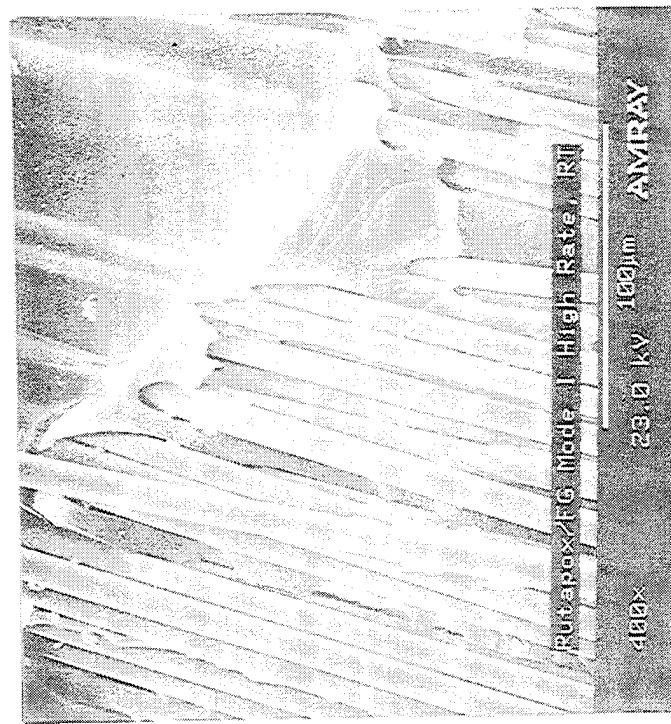
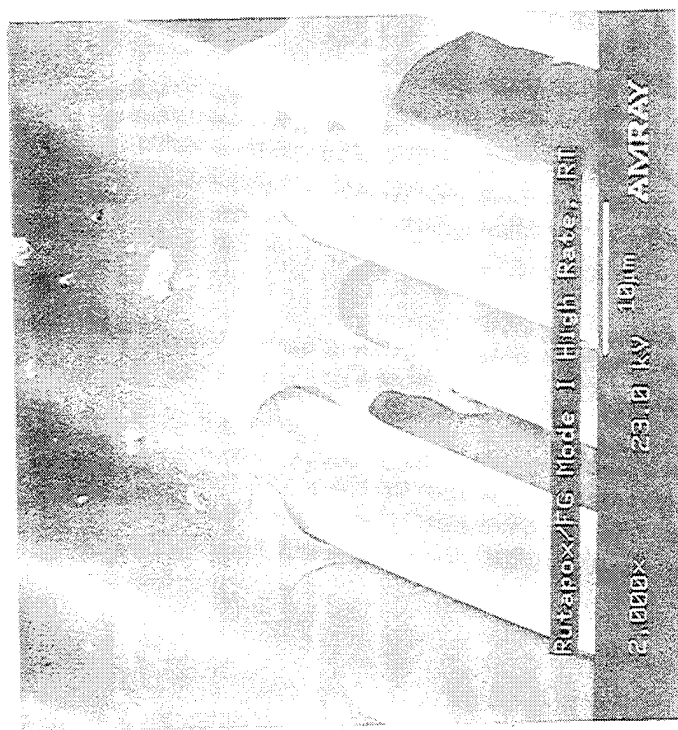
Figure 3.6.4. SEM Fractographs of a Rutapox/F-G Fabric Interlaminar Mode I (Tensile) High Rate Fracture Surface, RT

The fracture surfaces of both specimens exhibited similar features (Figure 3.6-4 & 3.6-5). The fabric tows parallel to the crack propagation orientation contained the hackles typical of a shear loading. Whereas the tows perpendicular to the crack direction exhibited ribbons of resin tearing from the fibers. The torn ends were generally bent towards the crack propagation direction.

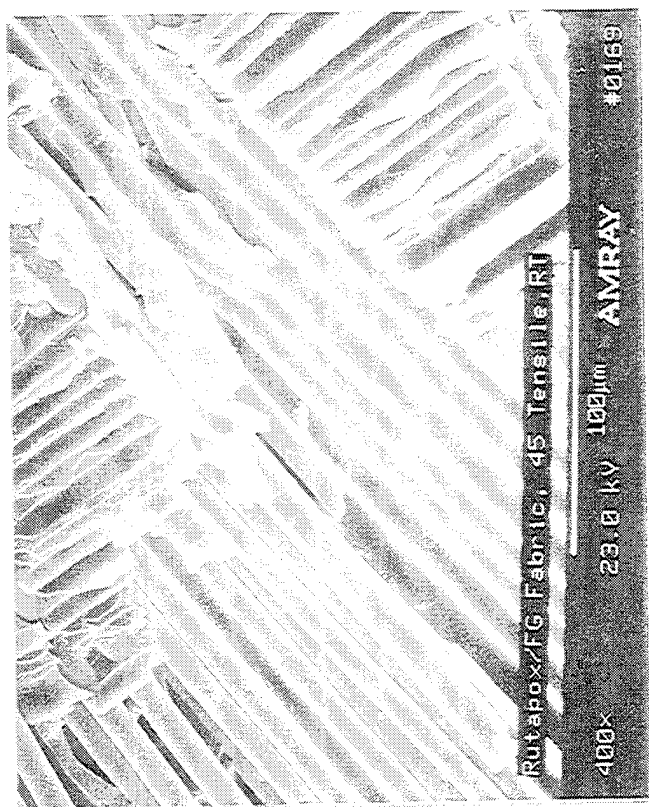
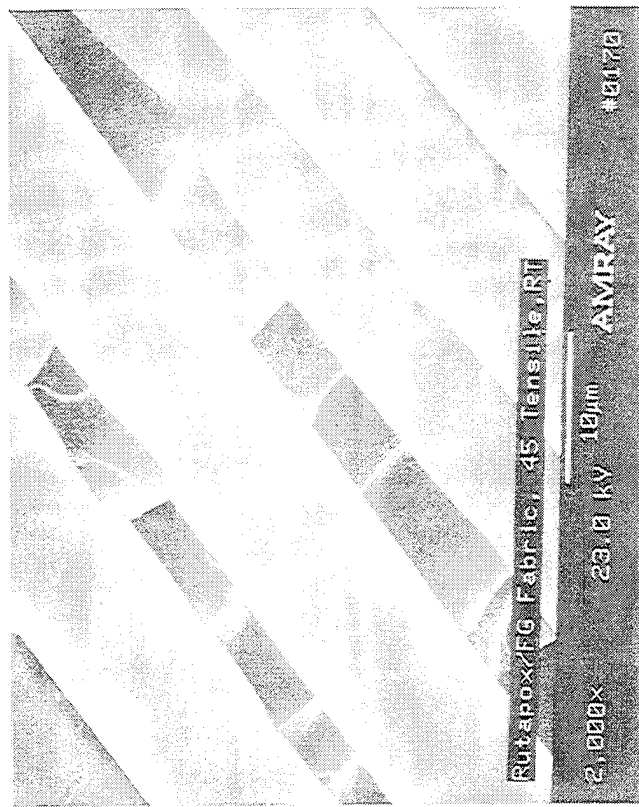
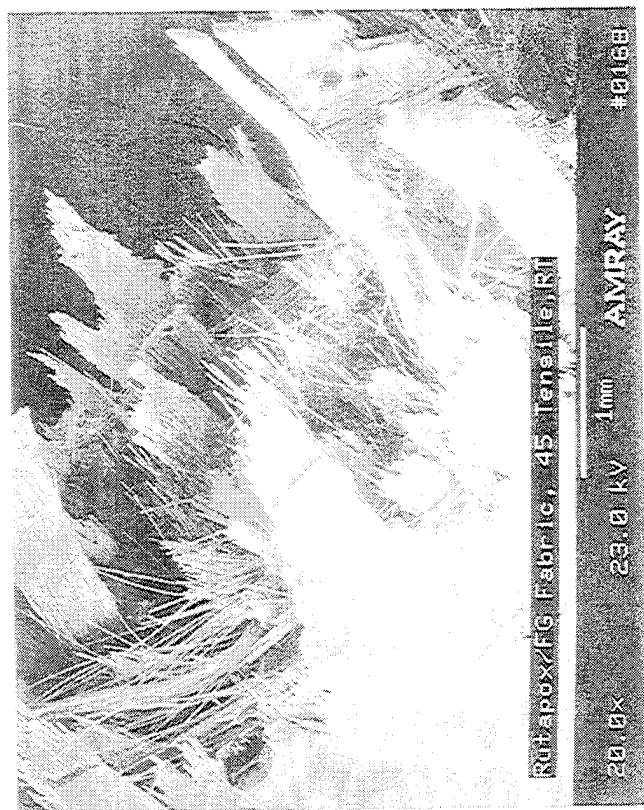
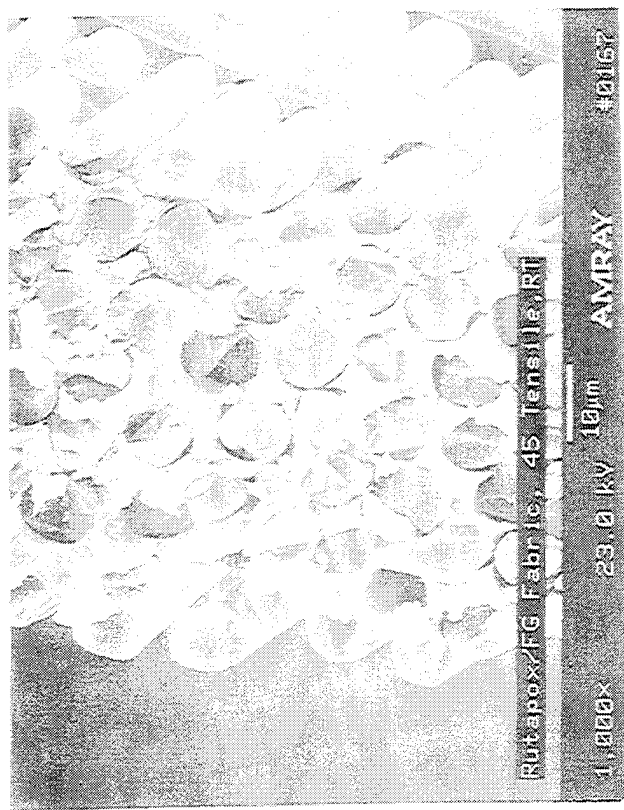
Figure 3.6-7. SEM Fractographs of a Rutapox/FG Fabric  $\pm$  45° Tensile Fracture Surface, RT

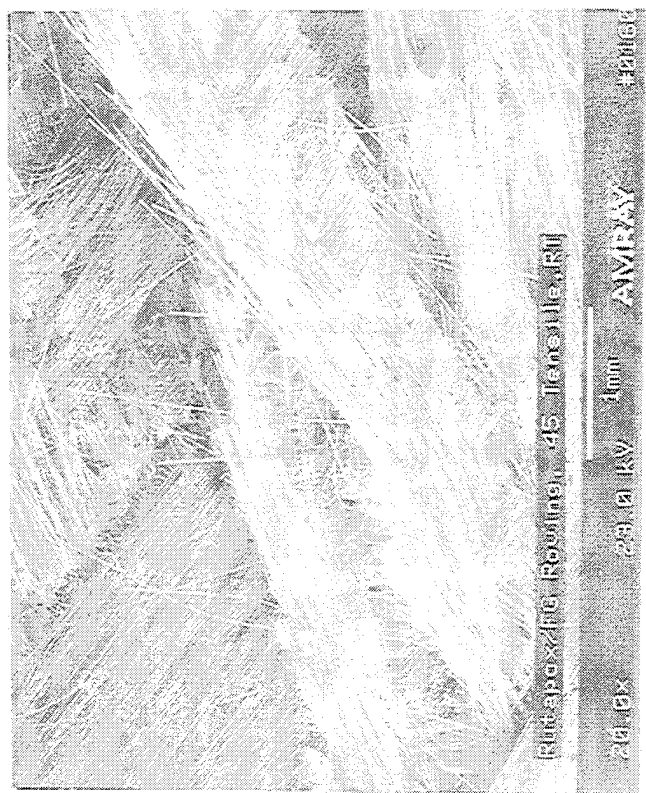
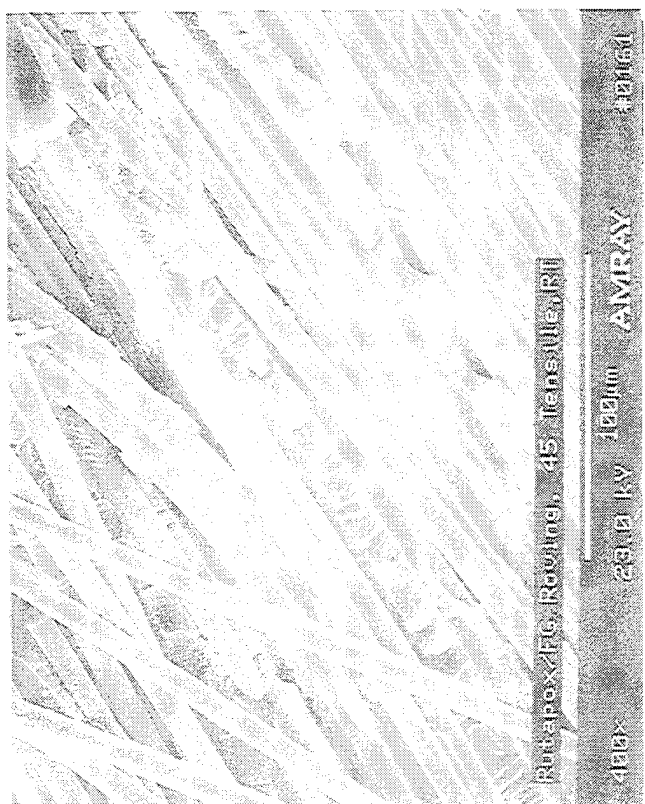
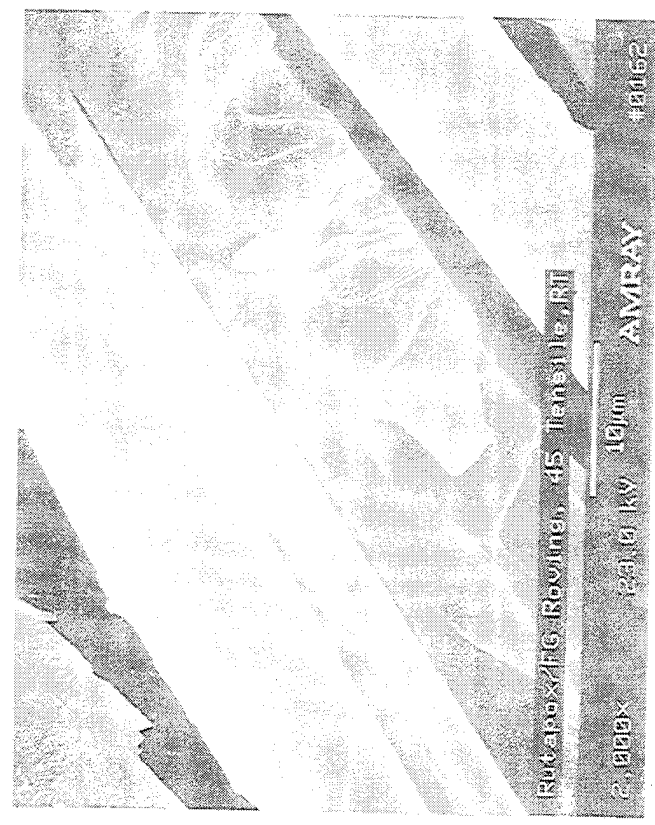
Figure 3.6-8. SEM Fractographs of a Rutapox/FG Rovings ± 45° Tensile Fracture Surface, RT

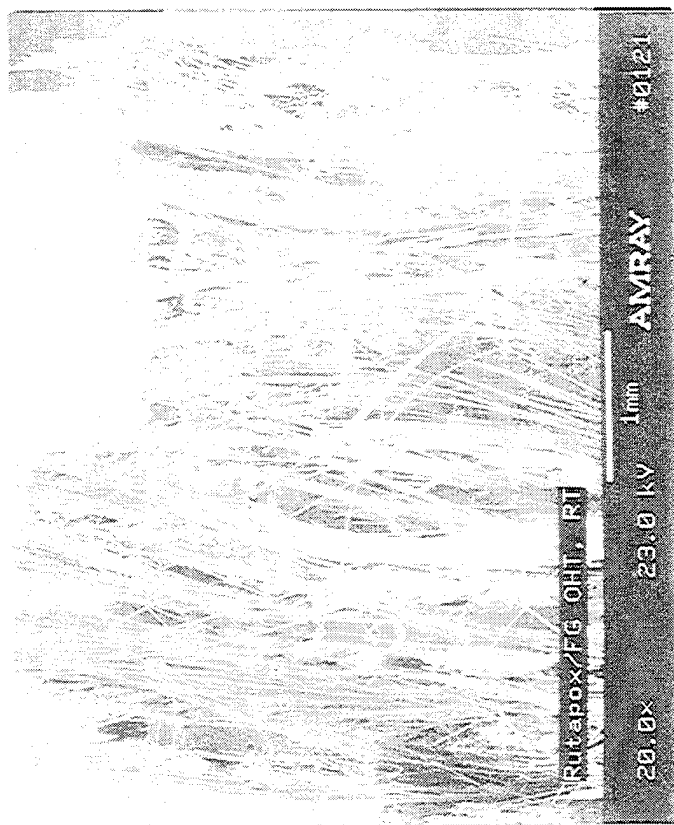
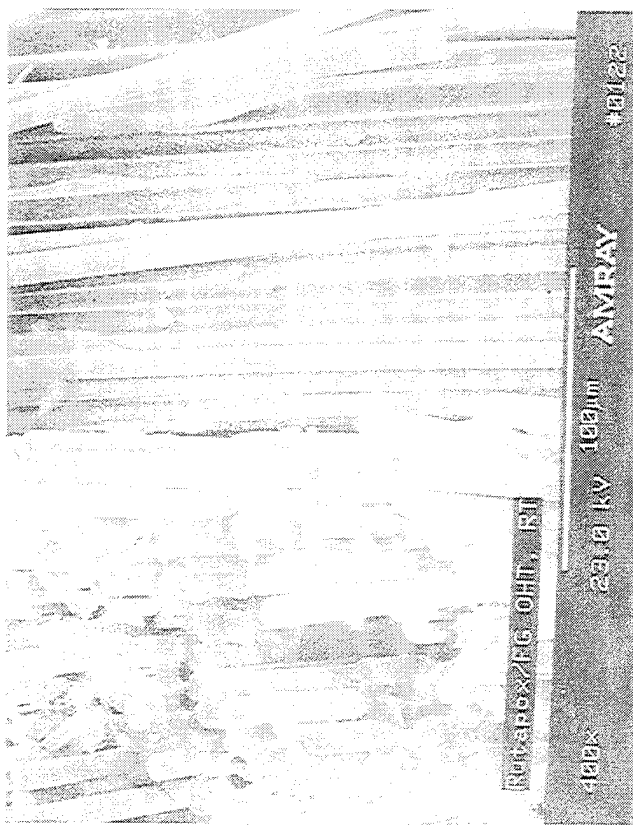
Figure 3.6-9. SEM Fractographs of a Rutapox/FG Fabric Open Hole Tension Fracture Surface, RT

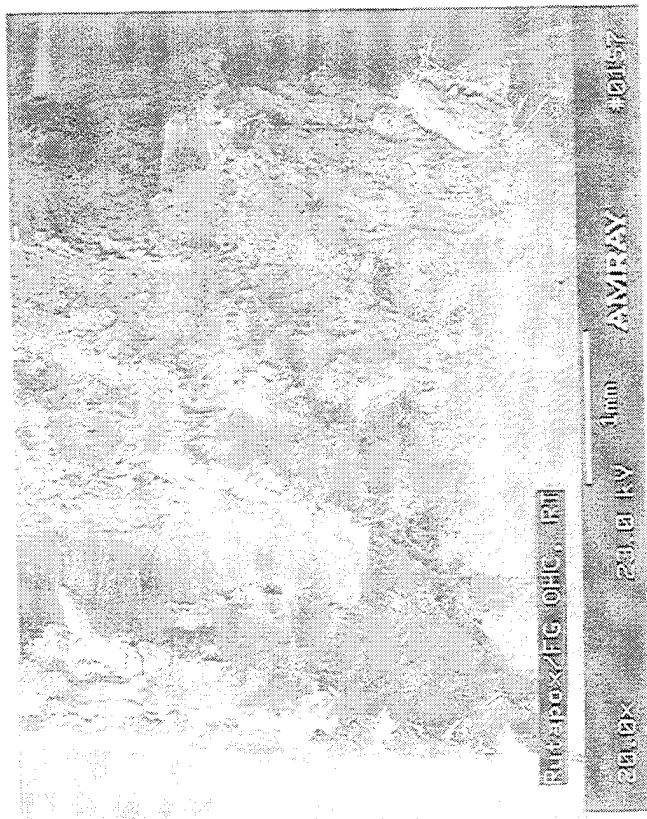
Figure 3.6-10. SEM Fractographs of a Rutapox/FG Rovings Open Hole Compression Fracture Surface, RT

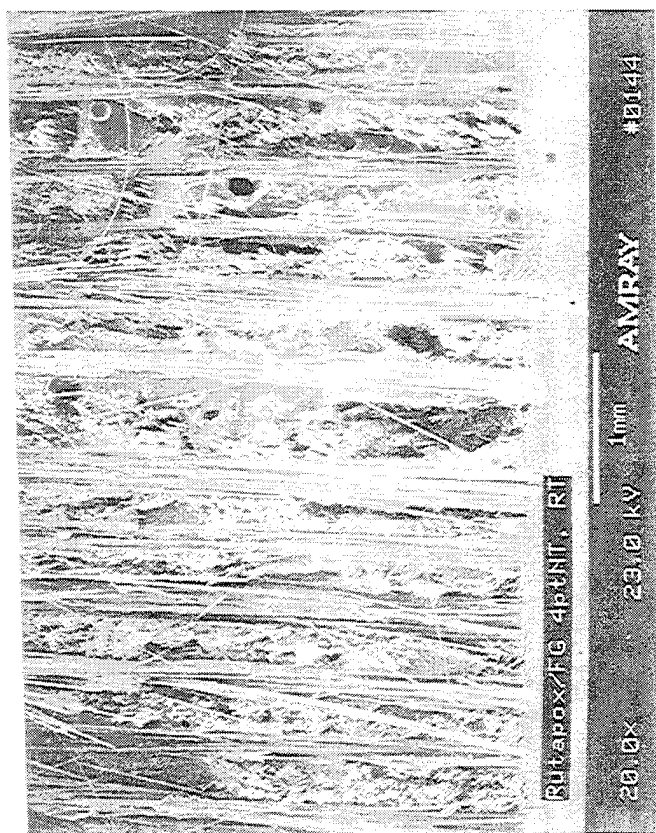
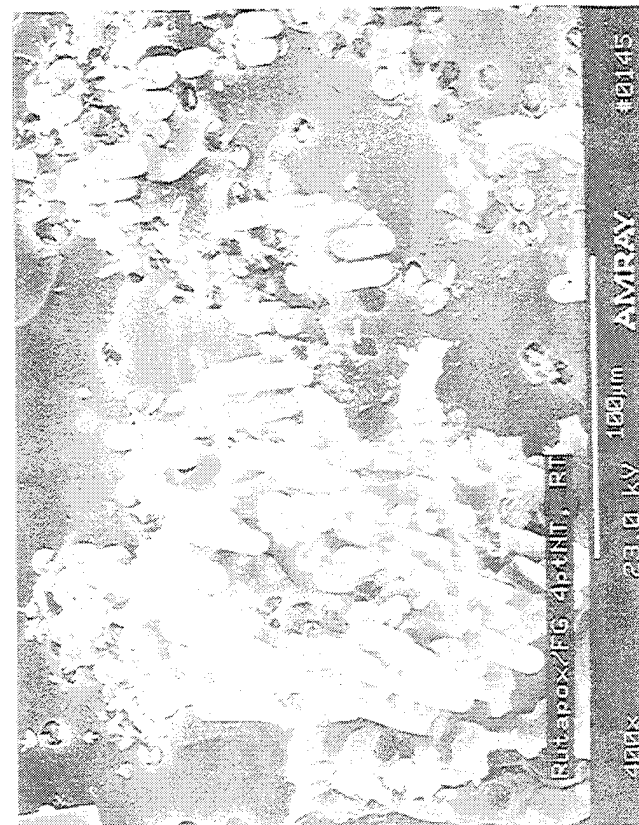
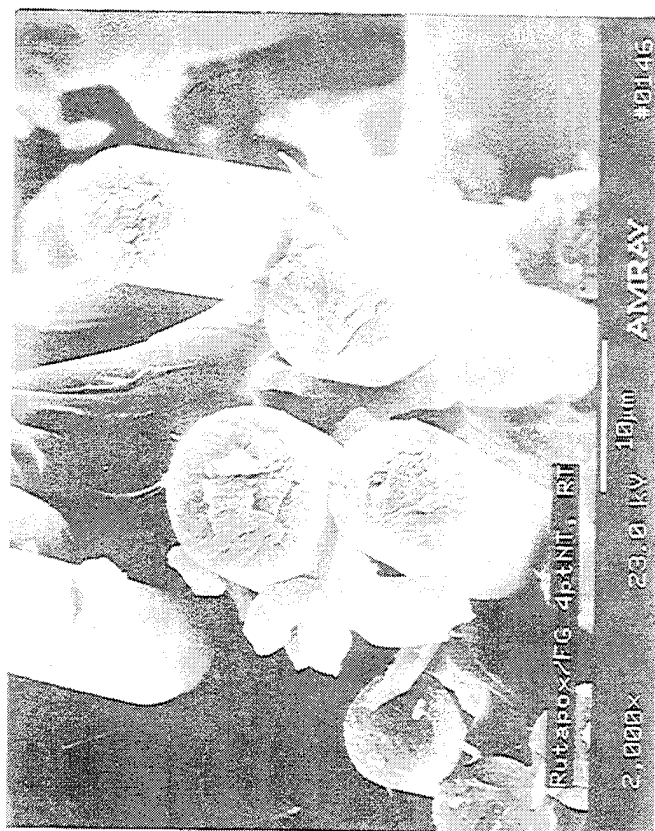
Figure 3.6-11. SEM Fractographs of a Rutapox/FG Rovings N4ptY Specimen Fracture Surface, RT
